PREPARED BY THE UNITED STATES ARMY BOARD FOR AVIATION ACCIDENT RESEARCH

OH-58 ACCIDENT SUMMARY

May 1969 through February 1971

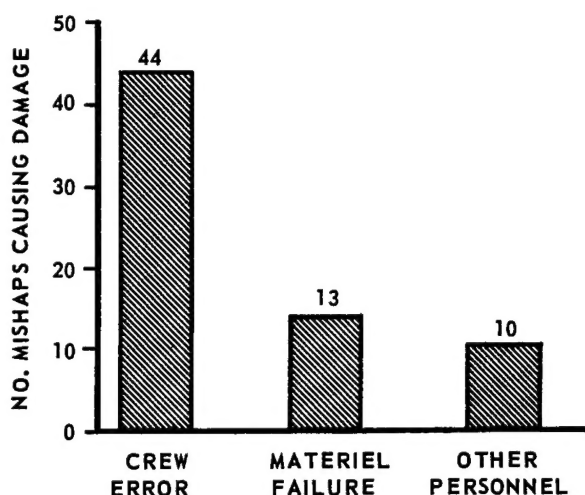
FIGURE 1
OH-58A Mishaps Resulting In
Damage Shown By Cause Factors

DISCUSSION. Figure 1 depicts graphically, by cause, 67 of the 202 OH-58A mishaps in which damage was incurred. As can be readily seen, crew error caused the preponderance of these 67 mishaps in which 17 fatalities and 15 injuries occurred. Crew error was listed as the cause factor in all of the fatal accidents and in 22 of the 37 incidents. Except for one injury, all injuries and fatalities occurred in the major accidents.

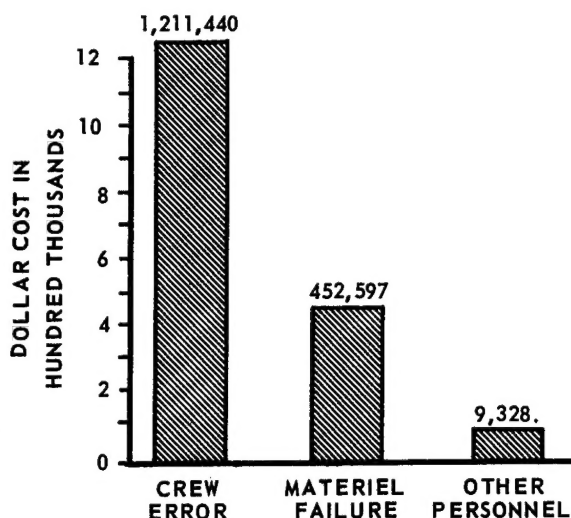
FIGURE 2
Mishap Costs

Figure 2 depicts the cost breakdown of the 67 mishaps by cause factors. Although secondary in significance by far to the loss of life, the loss in dollars sustained in both the fatal and

nonfatal mishaps is staggering. The OH-58A mishaps reported during this period cost the taxpayer approximately \$1,674,000. About 72 percent of this cost, or about \$1,212,000, was incurred in crew-error caused mishaps.

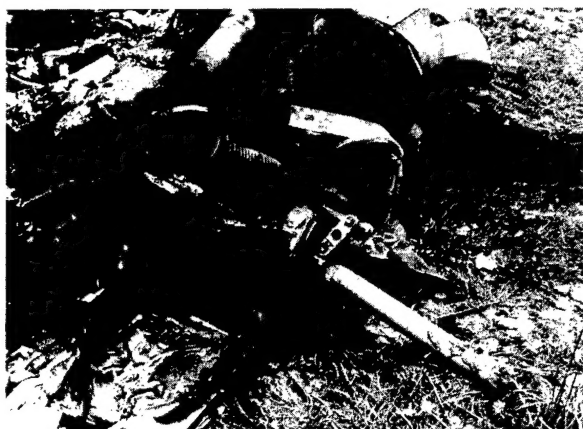
70032109--Engine failed during right turn and the aircraft lost altitude. Pilot applied collective, but the aircraft failed to respond. He continued to pull pitch and, just prior to impact, leveled the aircraft and applied aft cyclic to flare. The main rotor blades struck a tree, severing the rotor head from its mast, the tail boom aft of the stabilizer, and the right skid. Caused by pilot failing to take corrective action after engine failure. Cause of engine failure is unknown pending results of teardown analysis.

70032109 - Pilot failed to take corrective action after engine failed.

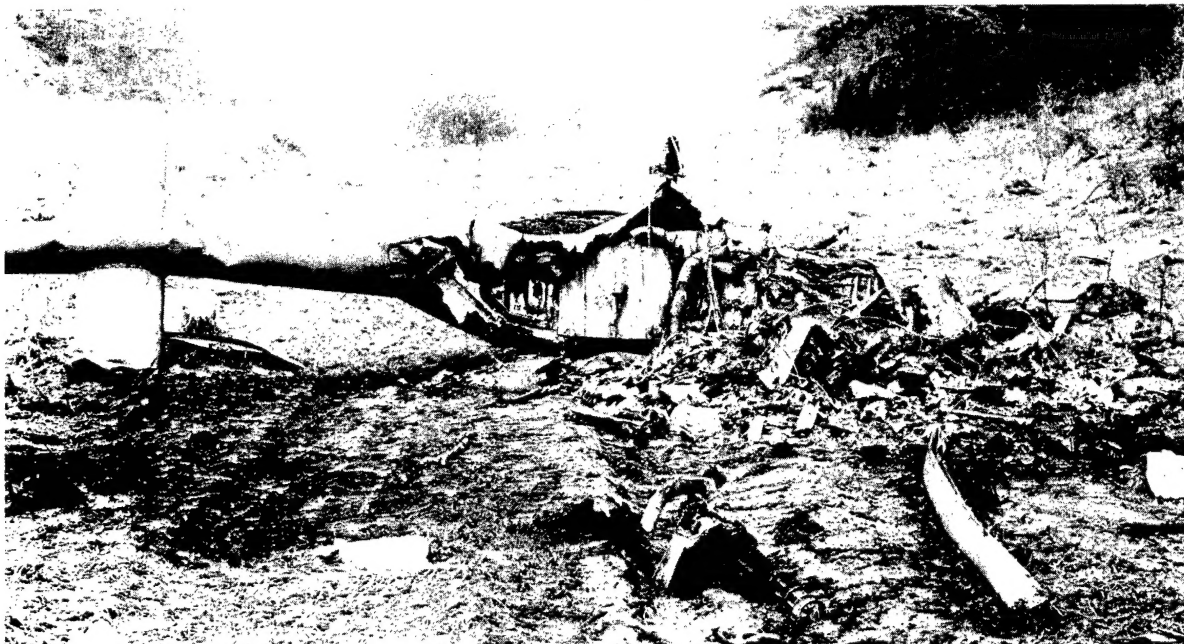
70040902--During low-level flight in a valley under conditions of rain, snow, and fog, aircraft struck powerlines and crashed. The pilot and observer were fatally injured and the aircraft was destroyed by postcrash fire. Caused by flying at unnecessarily low altitude and high airspeed for mission accomplishment, and failing to respond to warning of imminent wire dangers. Probable or suspected cause factors were (1) improper supervision within the unit of flight planning procedures and disregard of basic safety regulations, and (2) false impression on the part of the pilot that the powerlines ran parallel to the intended route of flight.

70040902 - Pilot failed to respond to warning of imminent wire dangers.

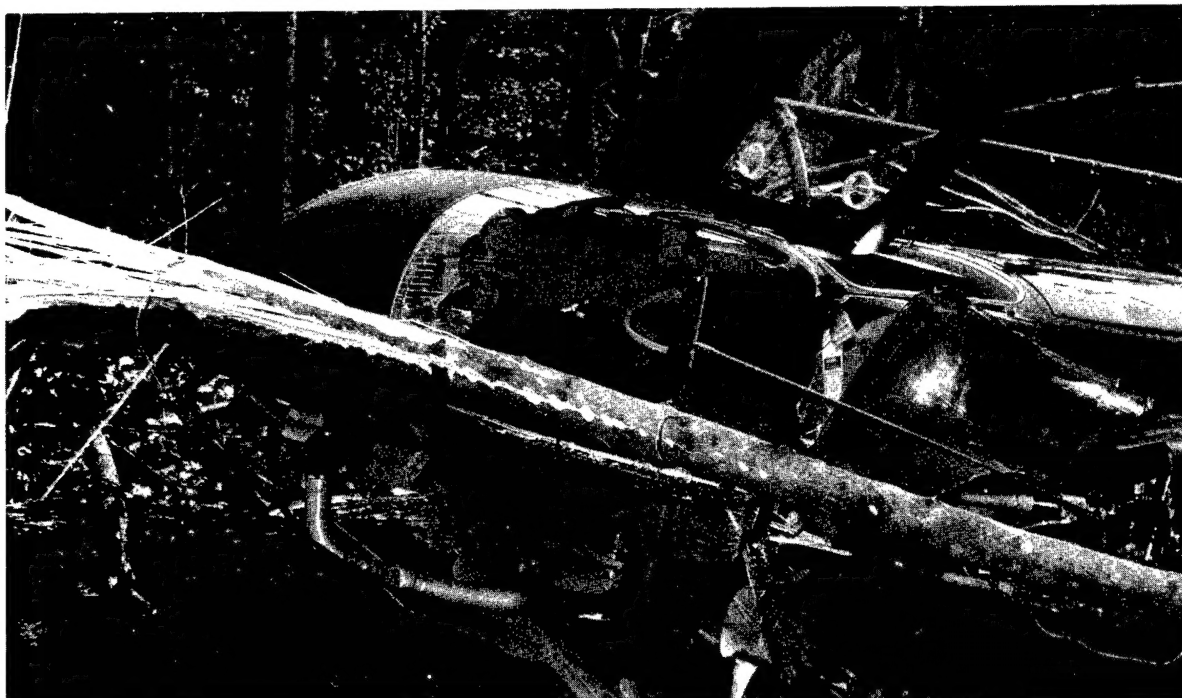
71012813--Pilot was on a low-level training mission. After 15 to 20 minutes of flight, he made a climbing turn coming from behind a ridge-line and the aircraft struck high tension wires, causing loss of antitorque control. He autorotated

71012813 - Pilot became disoriented and struck the trees.

tated from low altitude prior to entering trees. The aircraft descended through the trees and crashed on rocks in a streambed in a ravine, damaging the main rotor blades, right skid, vertical stabilizer, tail rotor gearbox, airframe, and skin. The pilot and two passengers suffered minor injuries. Caused by pilot disorientation. Contributing factors were (1) unapproved area for contour flying and (2) possible complacency.
